CENTRAL INTELLIGENCE AGENCY

25X1
COUNTRY	USSR (Arctic)	REPORT	25X1
SUBJECT	1. Warships in the Arctic 2. Possible Amphibious Operations at Kildin Island 3. Port of Onega	DATE DISTR. 12 October 1955 NO. OF PAGES 3	
DATE OF INFO.		REQUIREMENT NO. RD	25X1
PLACE ACQUIRED		REFERENCES	
DATE ACQUIRED		This is UNEVALUATED Information	25X1

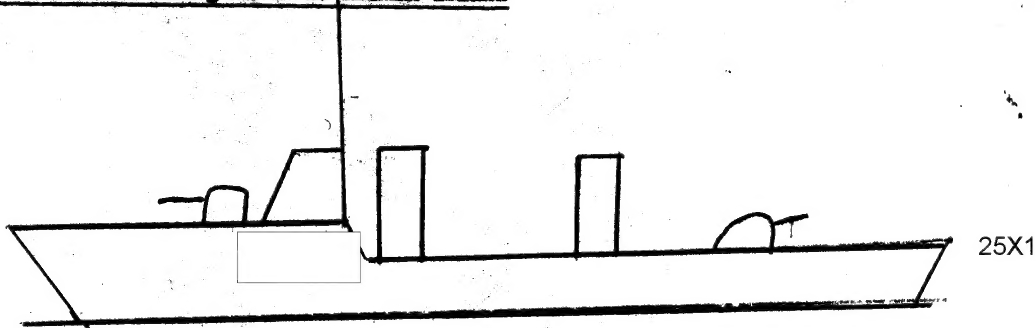
Sketch No. 1

Large vessels exercising north of Kildin Island

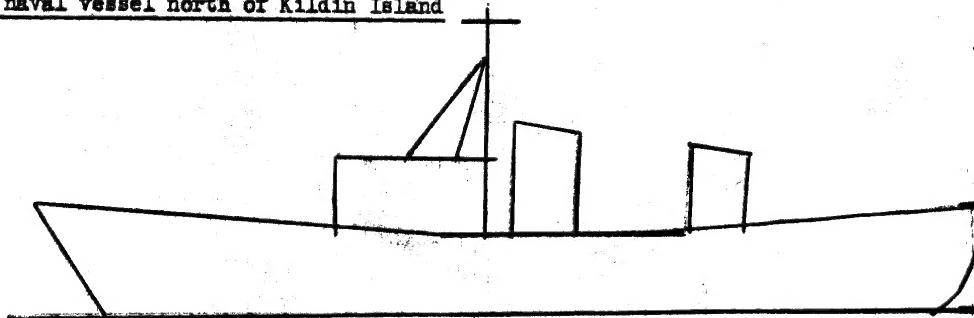
Sketch No. 3

Large naval vessel north of Kildin Island

4. At 1200 hours GMT on 14 June, a large naval vessel was on a northerly course north of Kildin Island. [redacted] was considerably larger than the vessels described above. It had a raked bow, a flush deck, a reverse sheer on the foredeck, a mast at after edge of the bridge, two similar funnels with raked cowls, and a cruiser stern (see sketch No. 3). 25X1

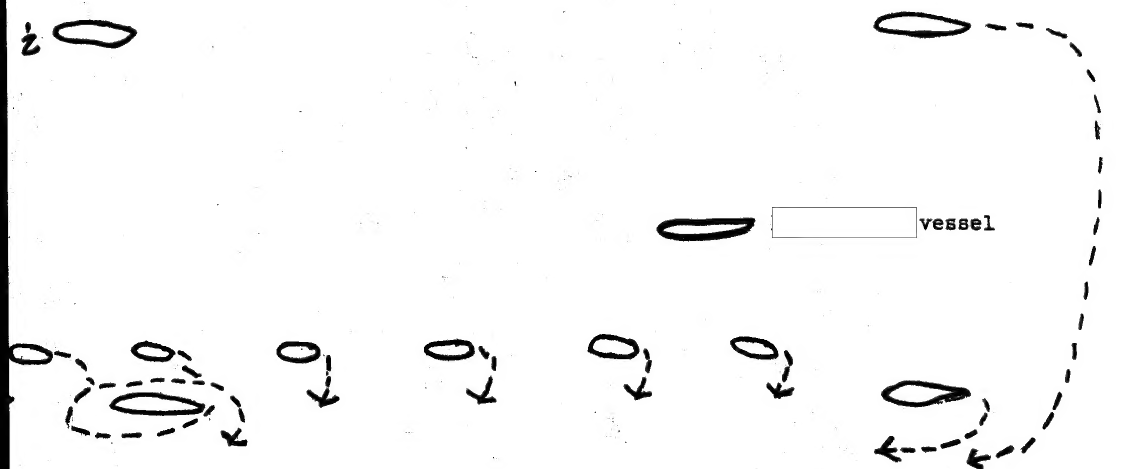
Sketch No. 4

Naval Exercise off Kilden Island

2. The large vessels sailed two and two in column on each side of [redacted] ship. The distance between them was about two nautical miles. The small vessels sailed in column two to three cable lengths north of the southernmost of the large vessels. The large vessels maintained a speed of about 12 knots and the small vessels a speed of about 20 knots, on an easterly course. The lead vessels made a right turn of 180°, the vessel on the starboard side of [redacted] ship made a sharp turn and the vessel on the port side made a wide turn. At the same time as the lead vessels turned, all the small vessels turned hard right and lay down a bright smoke screen behind them. The rear vessel on the port side also made a hard right turn to a westerly course but shortly thereafter turned right until it disappeared in a smoke screen on a southerly course. The maneuvers of the rear vessel on starboard side could not be observed. 25X1
